Manhole Inspection Summary

Manhole # **S43EE_042MH**

Insp Date: **3/10/08 1:24 PM**

Location Address: **1001 BOND ST**

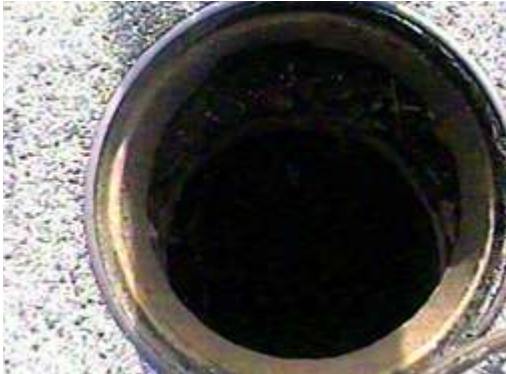
Defect 1

Frame Offset: **5** (in.) Condition: ☒ Sound ☐ Cracked ☐ Leaks

FRAME OFFSET

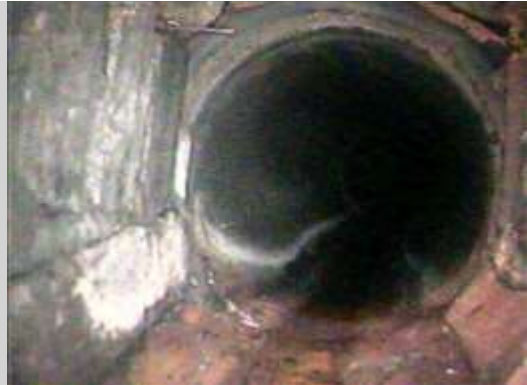
12 O'Clock Outflow

8 in. Circular Gravity Sewer
Pipe Out @ 12 O'Clock

Pipe Height: (in.) Direct
Pipe Material: **Clay** ☐ Pipe Lined
Invert Depth: **10.83** (ft.) Flow Characteristics: **Slow**
Deposits: ☒ None ☐ Mud ☐ Sludge ☐ Debris ☐ Grease
Silt Depth: (in.) Deposits Extent:
Infiltration: **None** Pipe Seal Cond: **Sound**

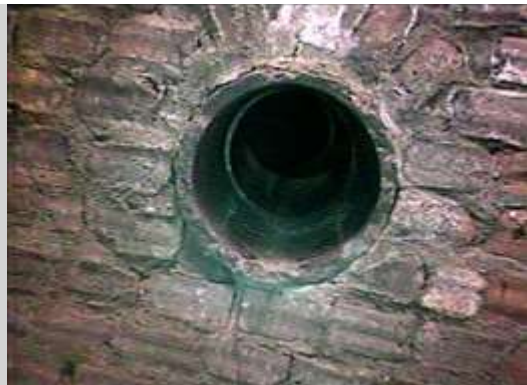
3 O'Clock Inflow

8 in. Circular Gravity Sewer
Pipe In @ 3 O'Clock

Pipe Height: (in.) Direct
Pipe Material: **Clay** ☐ Pipe Lined
Invert Depth: **8.89** (ft.) Flow Characteristics: **Slow**
Deposits: ☒ None ☐ Mud ☐ Sludge ☐ Debris ☐ Grease
Silt Depth: (in.) Deposits Extent:
Infiltration: **None** Pipe Seal Cond: **Sound**

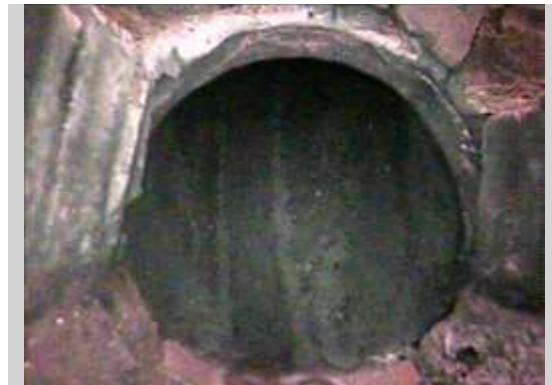
Drop In @ 3 O'Clock

Drop: **Outside Direct**
Angled: Reading: (ft.)
Inv Depth: **10.97** (ft.)
Drop Condition: **Open**
